Special Report 84-25

Cold Regions Research &
Engineering Laboratory

Salt action on concrete

John M. Sayward

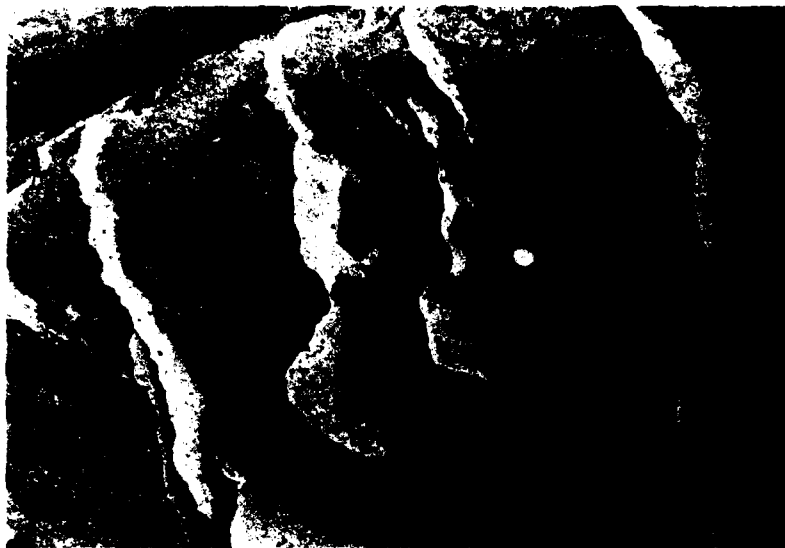
Figure 6. Seashore rocks pitted by salt and water-borne sand erosion, Sachuest Point, Middletown, Rhode Island, 1980. Note the dime for scale.

Wellman and Wilson's (1965) paper on salt weathering, which they considered a neglected erosive agent of desert and seashore rocks (Fig. 6), drew our attention to a mechanism clearly analogous to frost action. Logically it must also occur in salt action on concrete, where it has also been neglected. The concepts involved in salt weathering, frost action and crystallization pressure in porous matrices and their applicability to salt effects on concrete are further discussed in Appendix A.

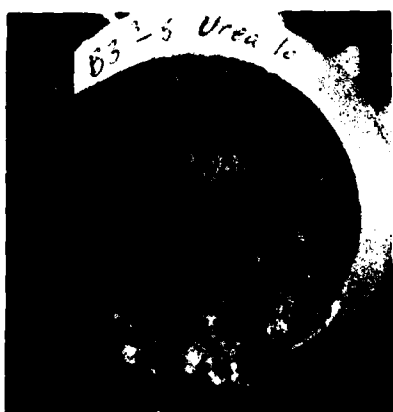
Figure 12. Typical crystal exudations, Period II (66 days).

Permeation, exudation, cracking, chipping and particle lifting are described in the following sections. Solid crystalline exudations had many forms: almost imperceptible hair-like fuzz, silky thread-like filaments or whiskers, uniform "grassy" white cover, thinly scattered or localized, straight, curved or curly, widely varying filament diameter and height, single or multiple filaments, plant-like clusters of columns, chunky or platy, fused crust and filaments patterned around stones. The photographs of Figures 11 and 12 are typical. Presumably the filaments may represent

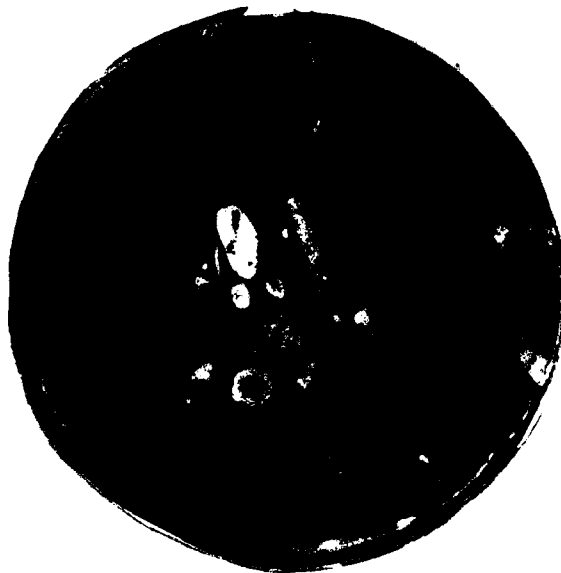
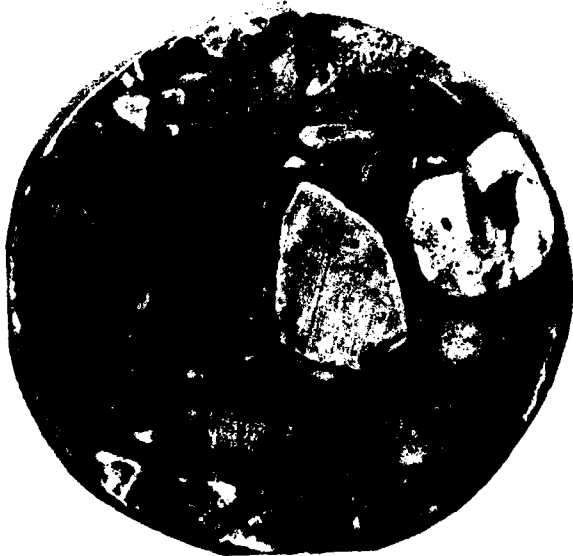
Figure 17. Drastic and early cracking of concrete F with CaCl_2 high.

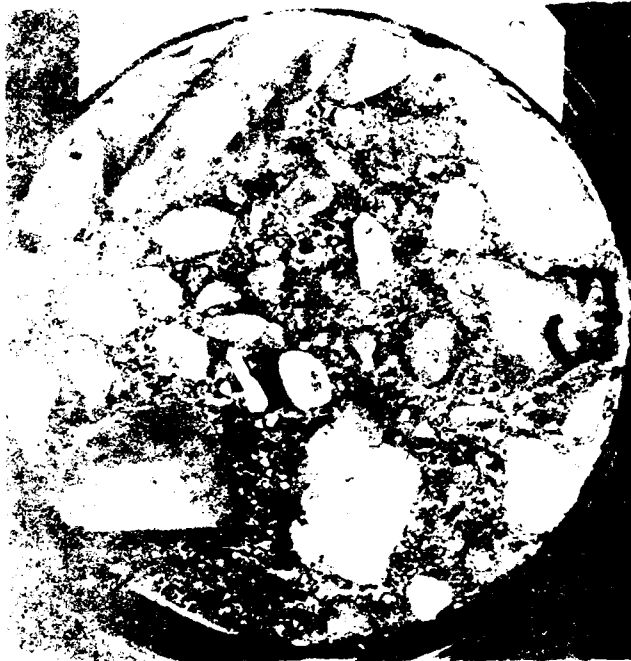
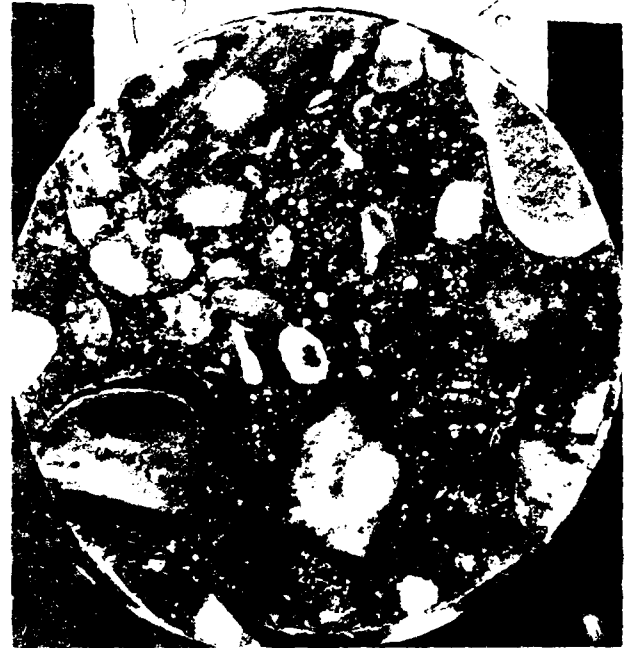
Although intact at first (Fig. 18a), within seven weeks of cessation, in storage Period IV, similar cracking developed in F3-3, CaCl_2 low (Fig. 18b). The solution had dried out since the last adjustment (petri dish 2/3 full) three weeks earlier. No others had dried out or cracked at this time. A year later, the dried-out F3-3 disk had not changed further (Fig. 18c).

Although apparently intact at 1 and 7 weeks, drastic cracking had also developed in F10-10, $\text{Ca}(\text{NO}_3)_2$ (Fig. 18d) within a year after suspension of the tests, when the disks had dried out unattended in the petri dishes. Thus, the cracking of F must not depend on the chloride ion. It may be due to the Ca^{++} ion, to the acidity of the salt reacting with the $\text{Ca}(\text{OH})_2$ of the cement paste, or to its hygroscopic property and ability to form hydrates [both CaCl_2 and $\text{Ca}(\text{NO}_3)_2$ do so].
